Willow North Watershed Monitoring and Standards and Guidelines Report

Glasgow Field Station
2005

This report updates the upland condition assessment and the progress made in those allotments that were not meeting the rangeland standards.

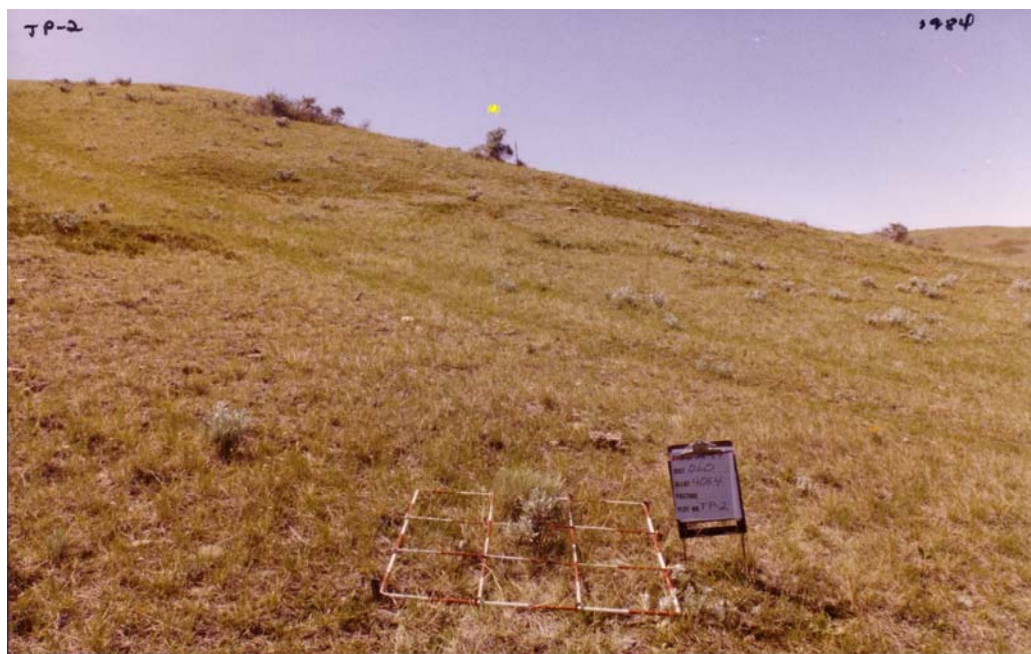
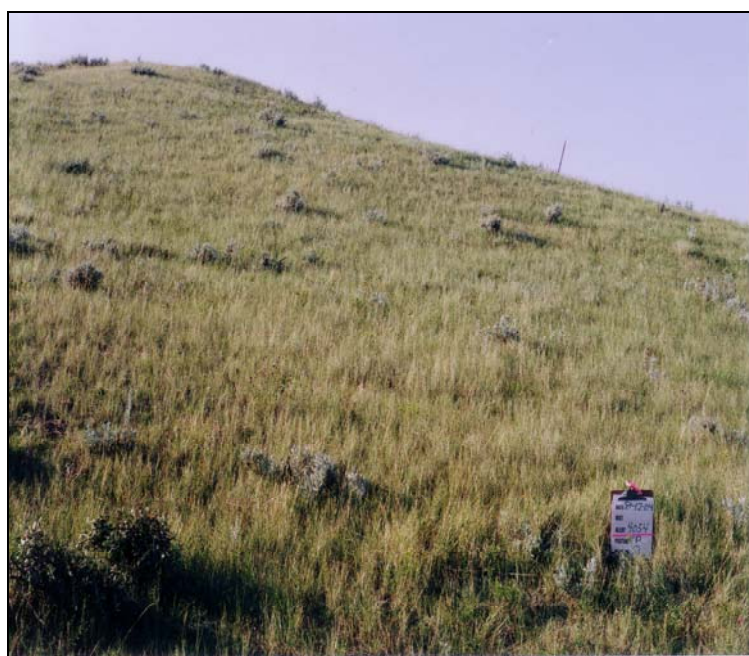
This set of three trend photos shows the typical shallow clay –clay ecological site in the watershed. The photos show a diversity of vegetative species (shrub, grass & forb). Notice the loss of buffalo berry bushes at the top of the hill. The die off is due to drought in the 1980s. The decline in buffalo berry is evident through out the watershed.

Allotment #4054 1982 TP2

Allotment #4054 1993 TP2

Allotment #4054 2004 TP2

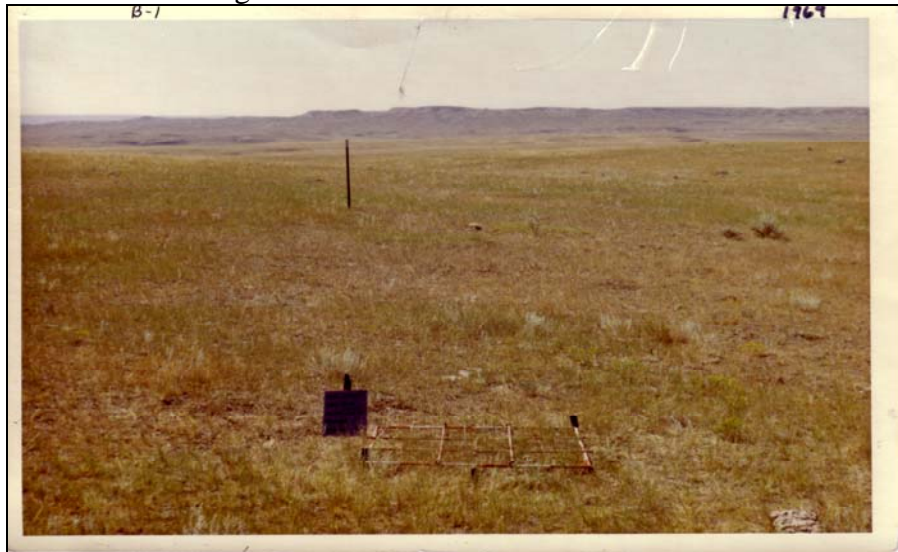
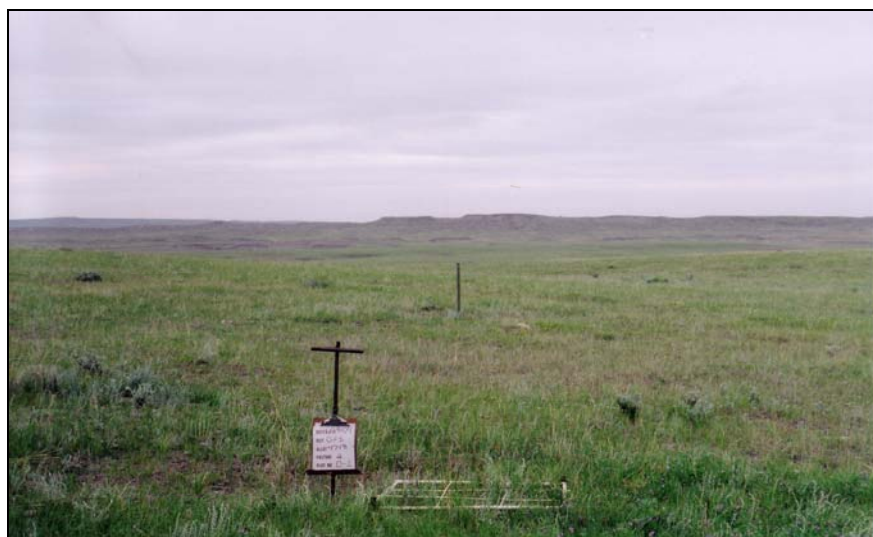
The following 3x3 trend photos in the Upper Willow Allotment #4718 show the typical silty upland site in the watershed. Notice the increase in grass cover since the 1970s.

Allotment 4718 1969 Plot b1

Allotment 4718 1981 Plot b1

Allotment 4718 2004 Plot b1

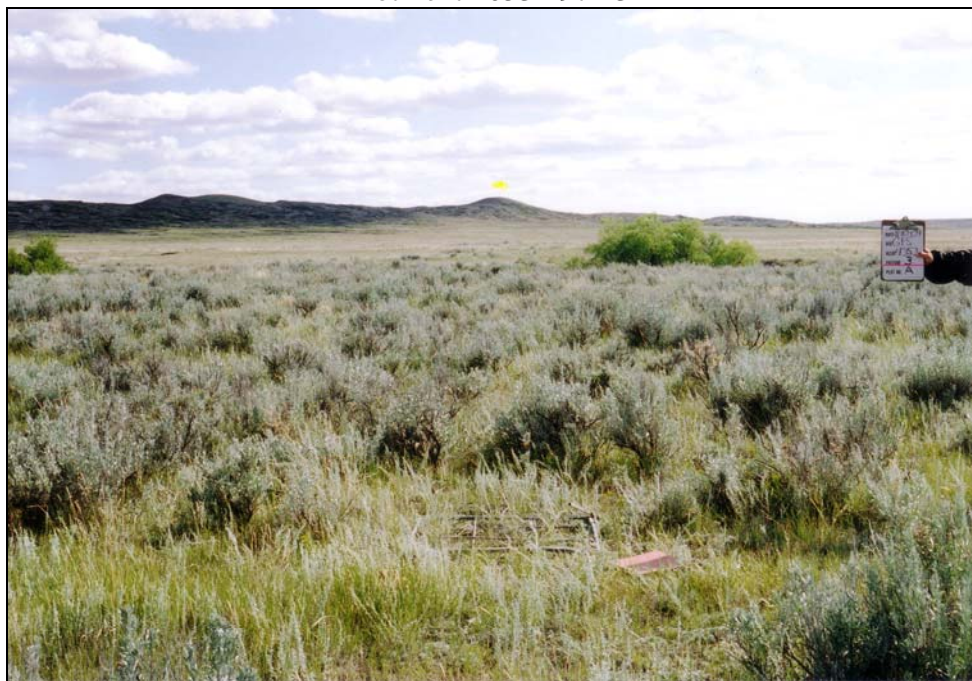
These two photographs show a sagebrush site on the Eastfork Willow Creek that has changed very little since 1974. Notice the new Peach leaf willow trees in the background

Allotment 4053 1974 3A

Allotment 4053 2004 3A

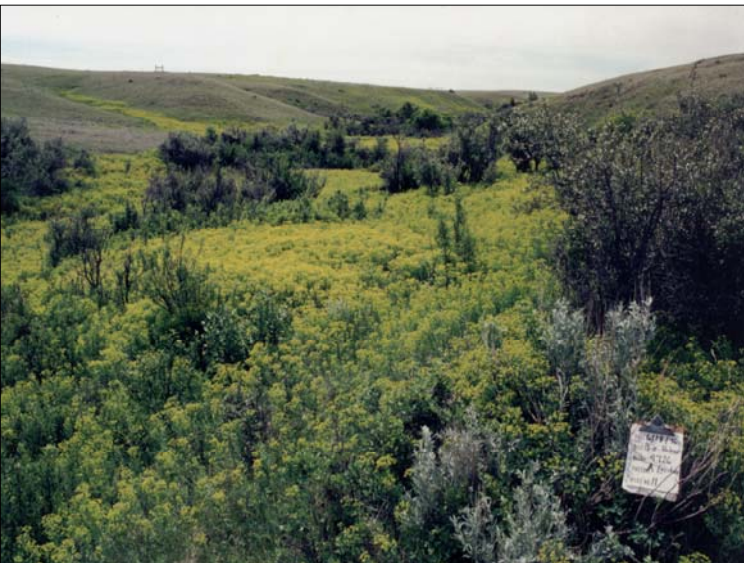
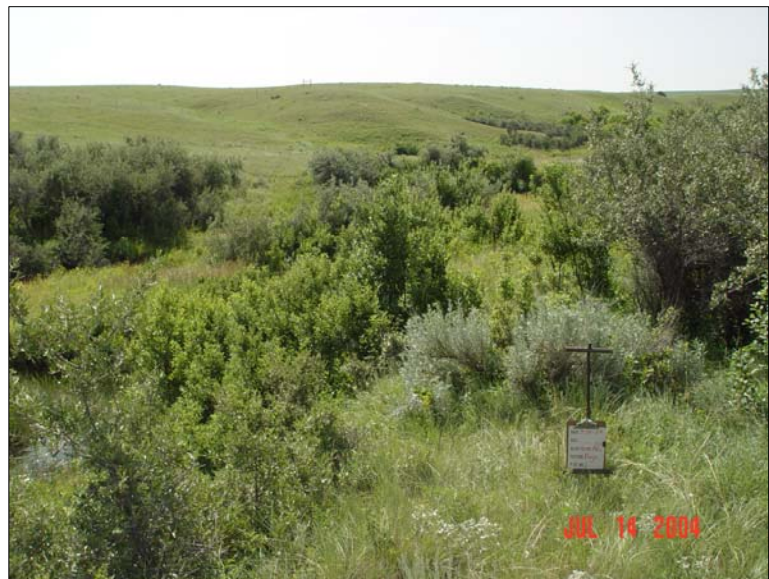
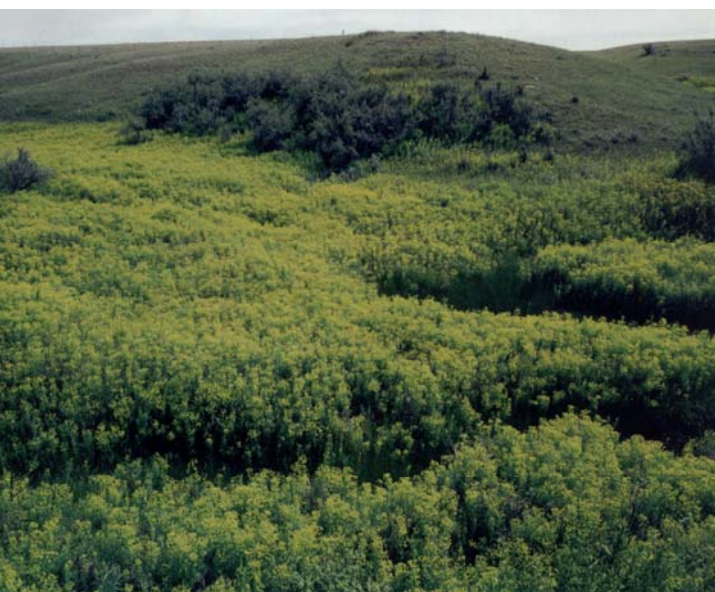
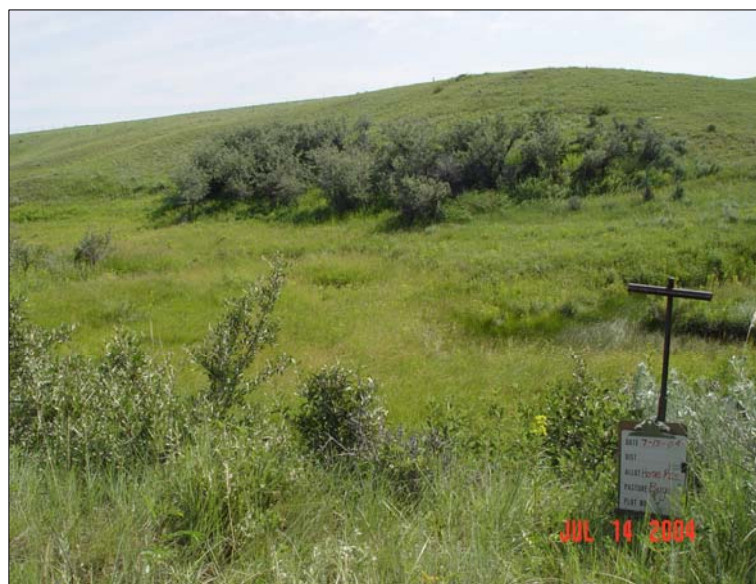
These photographs were taken inside of the spray boundary showing the impact of using beetles as a biological control. These pictures show the success we are seeing with biological control management.

The pictures above were taken below Hose Reservoir. The original pictures were taken in 1996, after the initial release of the *A. Lacertosa* flea beetles. The photographs show that the flea beetles are controlling the leafy spurge, allowing the native grass species to compete, thus returning the site to a native plant community.

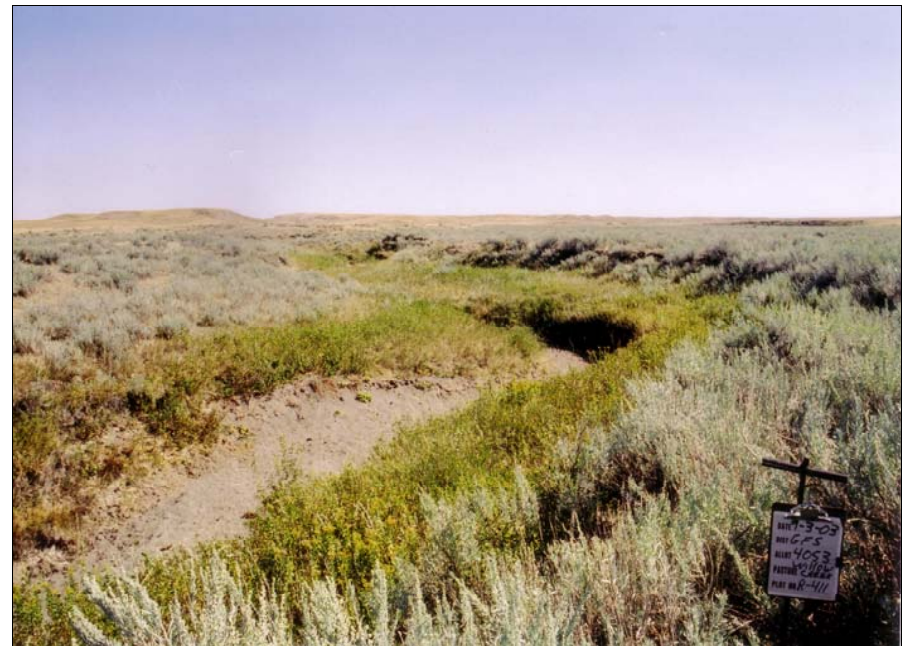
Allotment 4053 R-411 1997

Allotment 4053 R-411 2003

Improvement of this riparian area is attributed to higher than usual precipitation resulting in more bank vegetation.

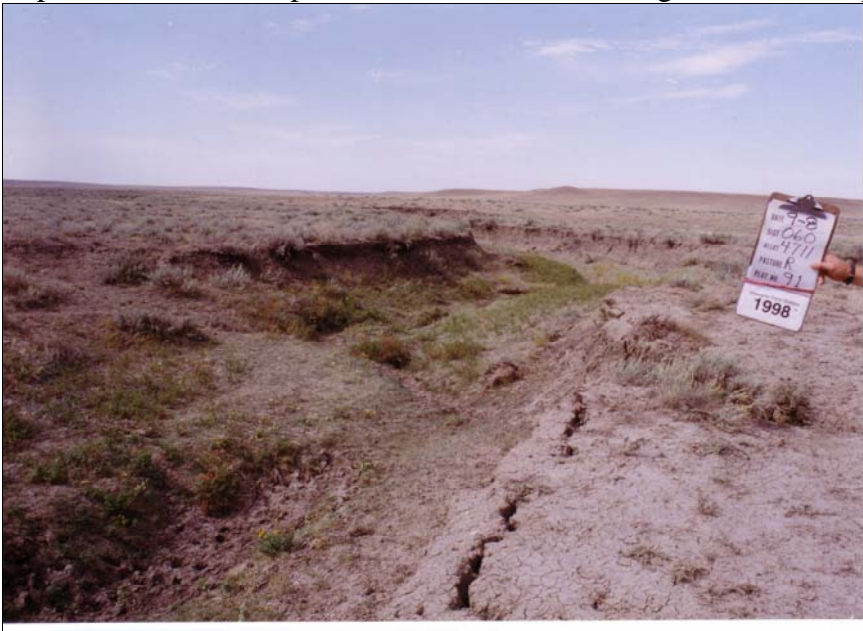
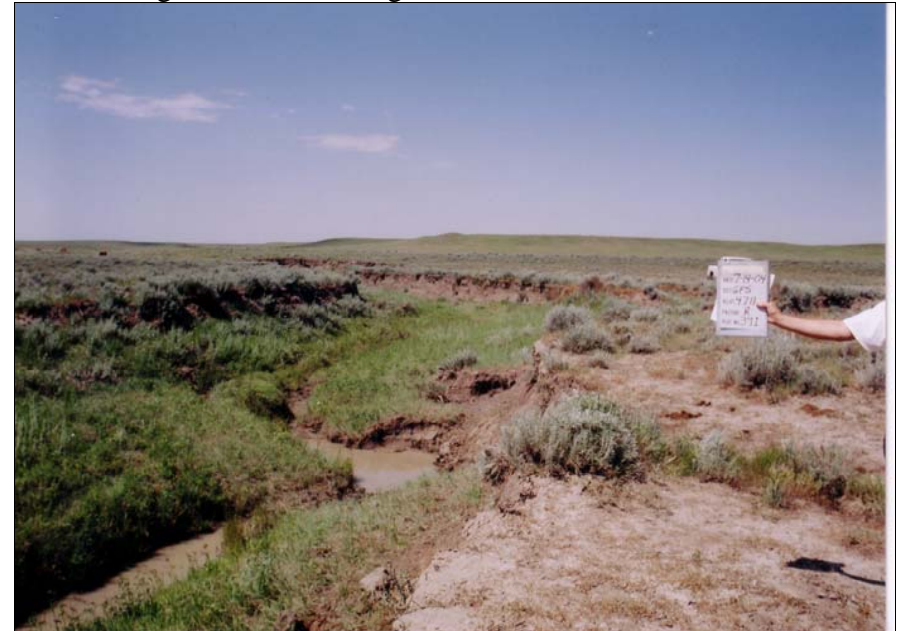
4711 R-391 1998

4711 R-391 2004

Larger amounts of precipitation have been a factor in the improvement of this riparian area, but the greatest influence has been a change in livestock management due to the implementation of a grazing system. Bank vegetation has increased and livestock trampling has decreased.

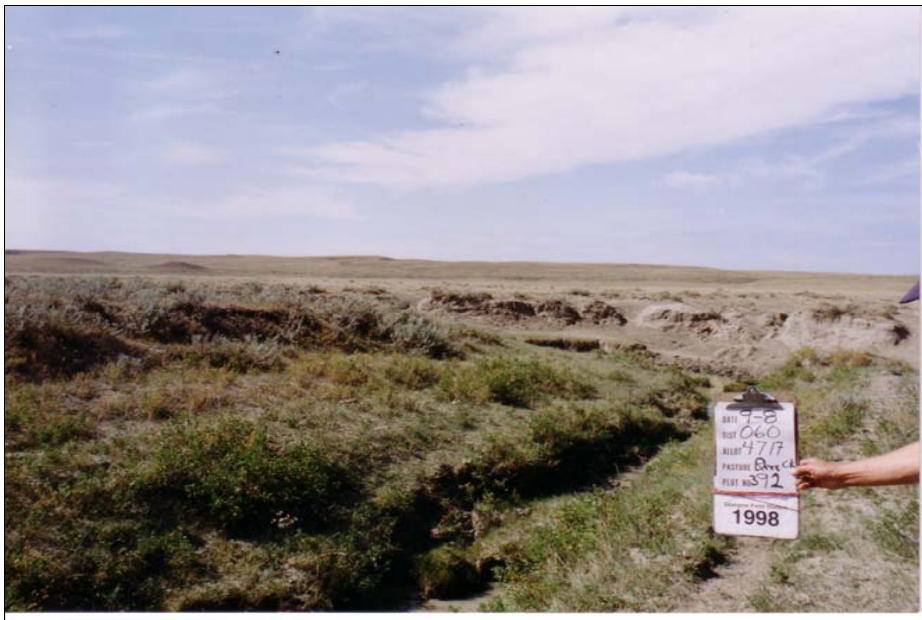
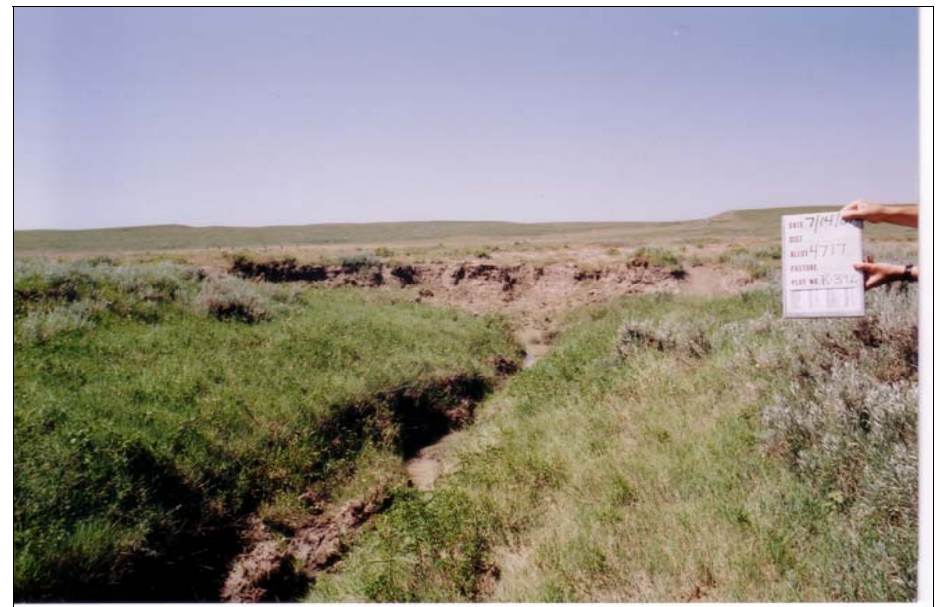
Allotment 4717 R-392 Deep Creek 1998

Improvement of this area is attributed to changes in livestock management as a riparian pasture grazing system was implemented resulting in less grazing use on Deep Creek. The cover of stream bank vegetation has increased and hoof action by livestock on the bank has decreased.

Allotment 4717 R-392 Deep Creek 2004

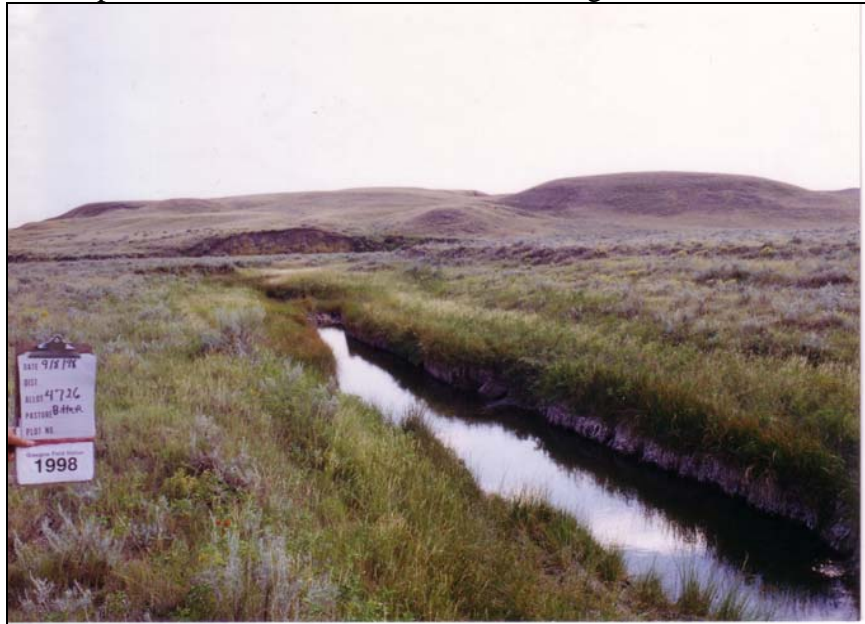
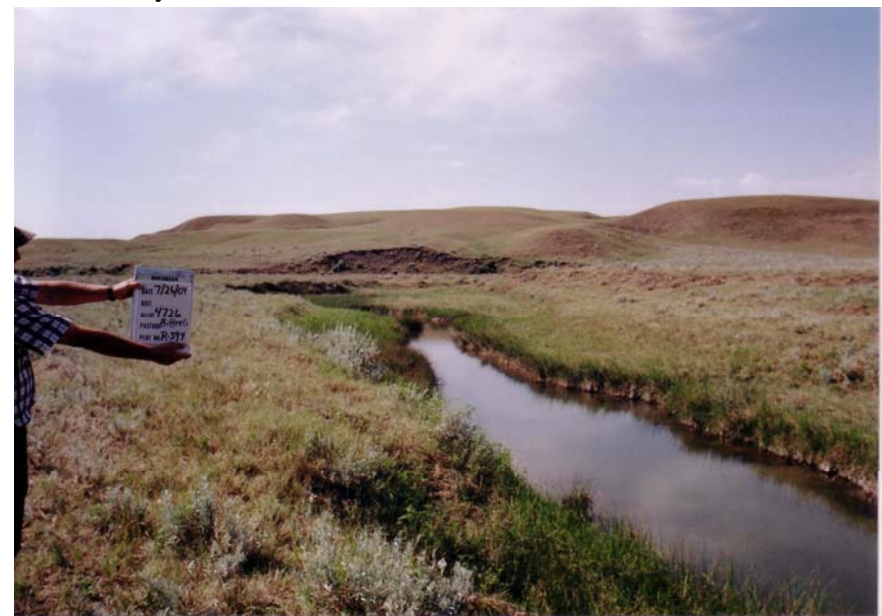
Allotment 4726 R-394 1997

Bio-control has decreased the amount of leafy spurge, a noxious weed, which was the biggest factor in the functioning-at-risk condition of the area.

Allotment 4726 R-394 2004

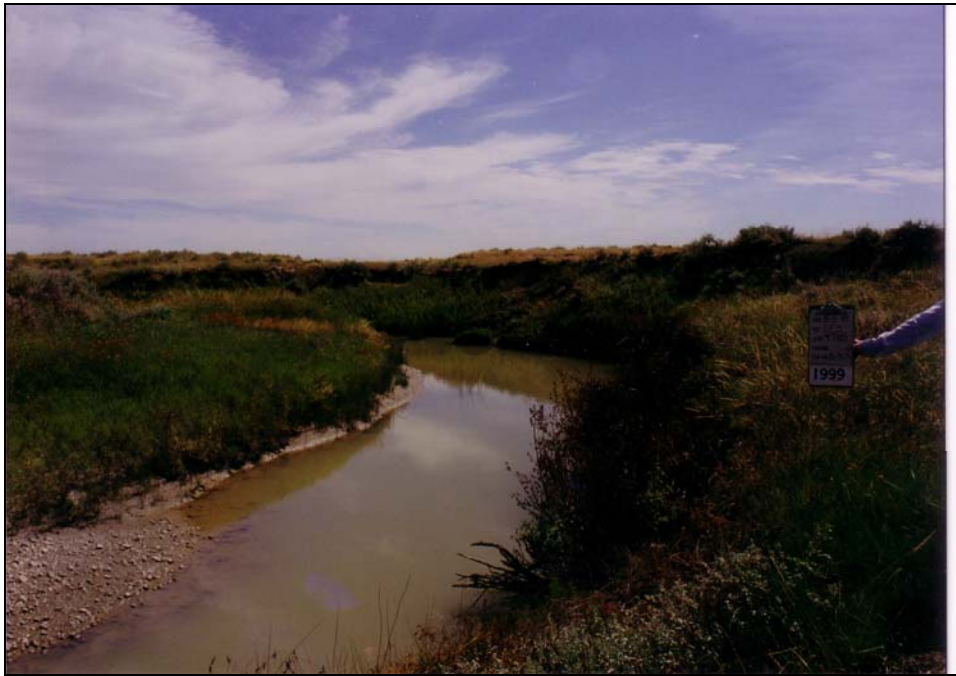
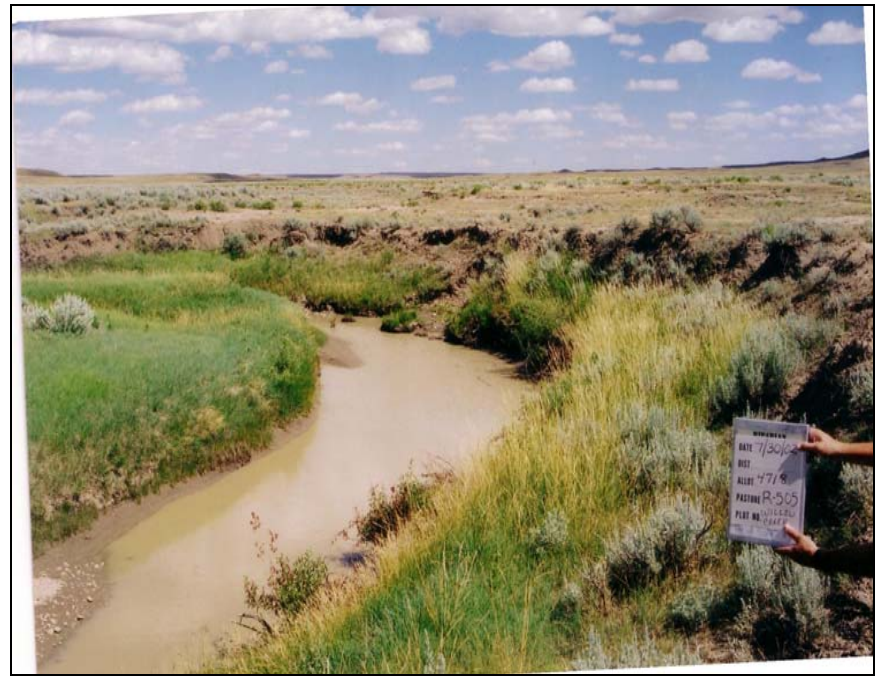
Allotment 4718 R-505 1999

Leafy spurge was again the reason for the functioning-at-risk rating. It has since been treated and the riparian area is now in proper functioning condition.

Allotment 4718 R-505 2004
